Board1 Report

555 Timer Circuit

ECEN5730 Fall 2025
Hyoungjun Chang

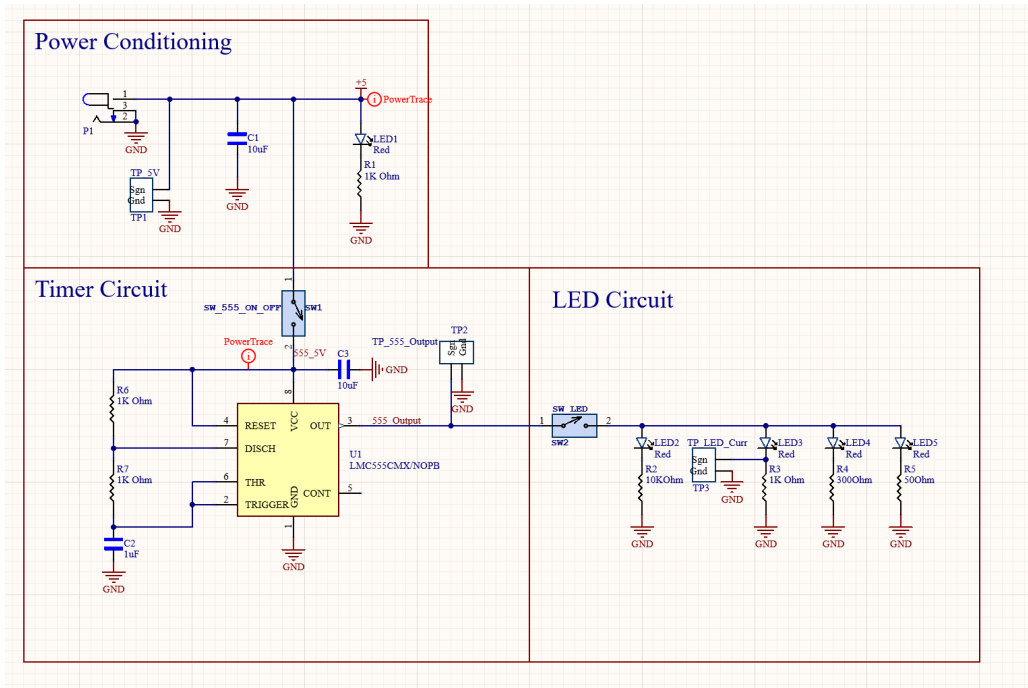
Altium Designer Schematic

Resistor values were changed from 100k to 1k ohms, and the 555 capacitor to 1uF, to match the available parts. Capacitors next to power lines were increased to 10uF to reduce power rail bounce.

Additional parts, such as Power Conditioning circuit (for power supply), and LED indicators were added as well. Test points were added for future debugging, and 2 switches were added to isolate different parts of PCB.

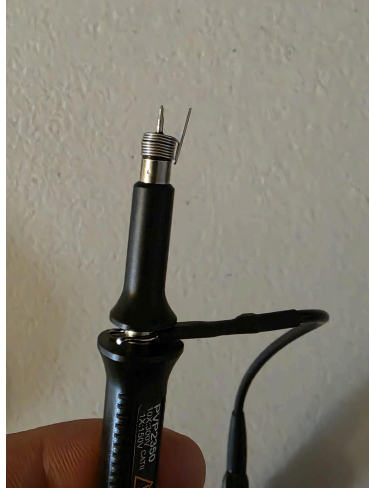
Spring Connector used in 10x Probe (left), TP1 power rail 5.5V output (right)

Signals inside all test points (TP1, TP2, TP3) were reasonable, but had some surprising results. Oscilloscope probe and spring connector (for ground) was used to measure signals for all test points to minimize noise.

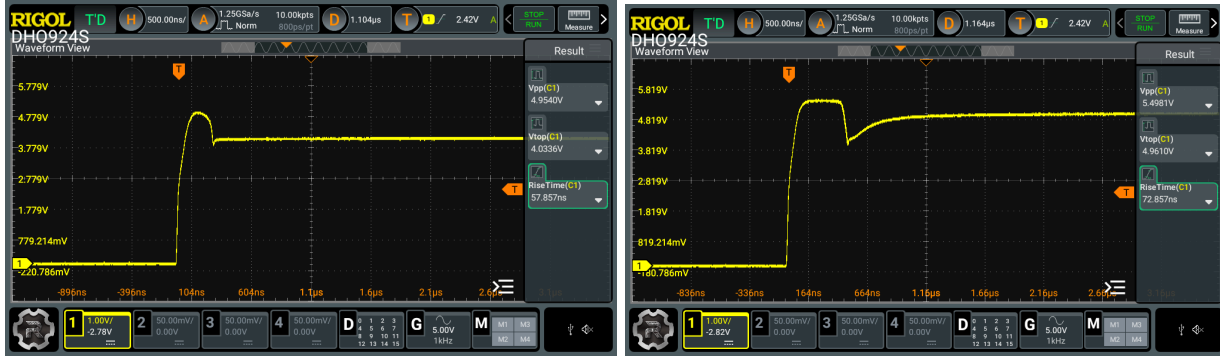
Zoomed in TP2 signal, LED on (left), LED off (right)

Further zooming into the signal shows that the initial “overshoot” is not an overshoot, but a parasitic component in the circuit. with a rise time of around 50n. It initially reaches 4.95V, close to supply voltage, then dips in voltage to 4V with LEDs on.

There was a difference in output when the LED was turned off - stable high voltage rose from 4.03V to 4.96V, and the “overshoot” reached 5.5V, which is equivalent to V_{pp} of power rail. This suggests that LED loads cause the 555 timer output voltage to drop, but the initial “overshoot” is not the result of LEDs by themselves.
